# Property Inspection Report

- The Habit Wellington Ltd -

## Inspection Details - Property Inspection Report

*Date:* 23/11/2010.  
*Time of Appointment:* 01:00 p.m.  
*Inspection For:* Paul 027 5555 725

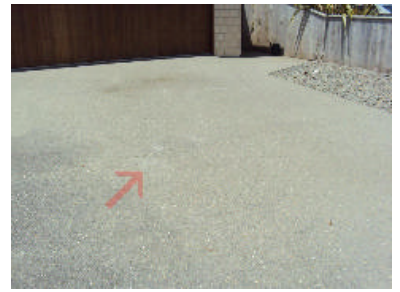
*Image Site Area 2:* Exposed Aggregate driveway in good condition.

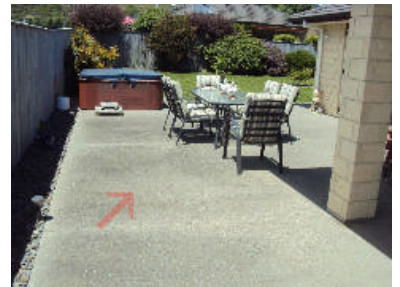
*Image Site Area 3:* Back Patio area, back yard fully fenced off.

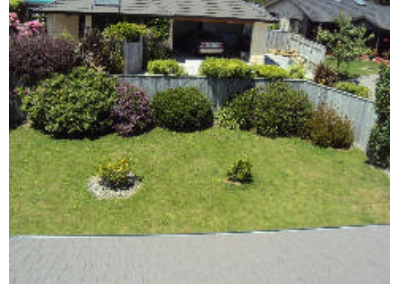
*Image Site Area 5:*

Well established back garden.

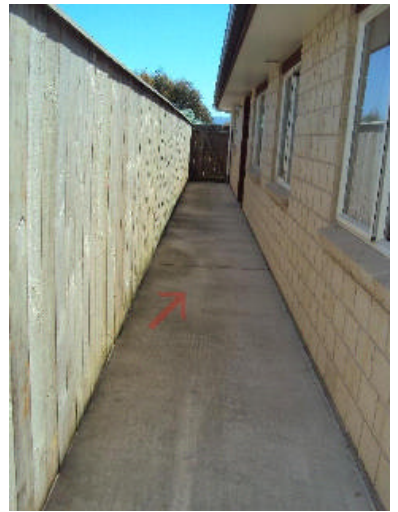
*Image Site Area 7:*

Plain concrete path down the side of the house.

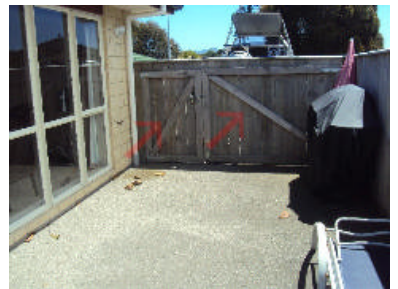
*Image Site Area 8:*

I could not open these gates as they were padlocked shut. They are designed however to both open right up to gain access to the back yard.

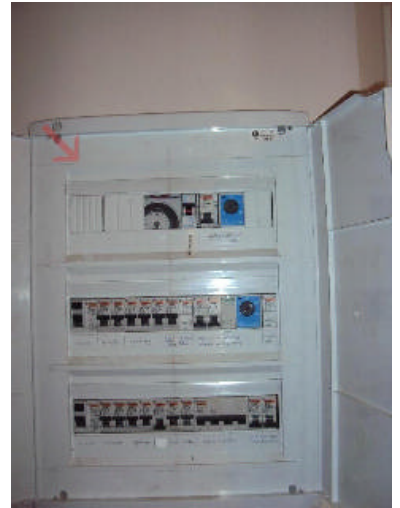
<i>General:</i>	Double, Attached with Internal Access.
<i>Side Doors:</i>	multiple, Hinged door, Functions as designed, Good Condition.
<i>Door panels &amp; reveal areas</i>	Material in, Good Condition.
<i>Internal linings:</i>	Lined, Manufactured trusses, Well secured, Material in, Good Condition.
<i>Lighting and power points:</i>	Lighting installed, Power points installed.
<i>Tested:</i>	Tested, Working.
<i>Window reveals &amp; sashes:</i>	Aluminum frame, Functions as designed, Good Condition.
<i>Internal:</i>	Laundry area, Separate storage area, Material and area in, Good Condition.
<i>Flooring</i>	Concrete floor slab (unpainted), Good Condition.
<i>Garage Floor Measurement, Approximately:</i>	48 meters squared.
<i>General summary and comments from the inspector on this area.</i>	Good Condition. Well constructed, well presented.
<i>Garage Image 1:</i>	Fuse box in the garage.

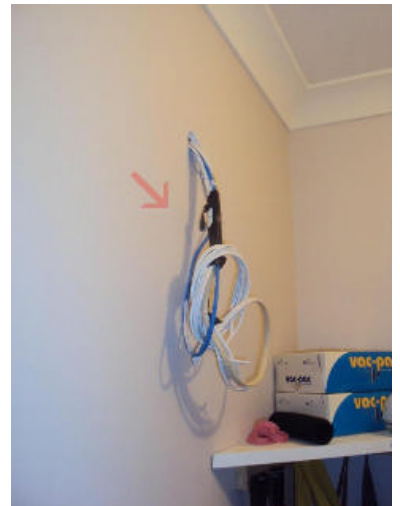
<i>Garage Image 2:</i>	Cords hanging out of the wall in the storage cupboard.
------------------------	--

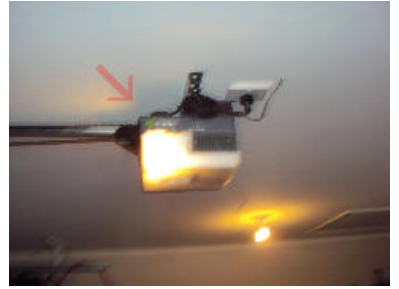
Garage Image 3:

Electric garage door is in working order.

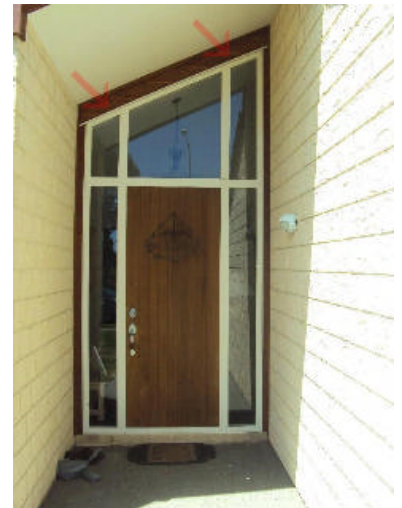
<i>Borer:</i>	No.
<i>Mildew:</i>	No mildew evident.
<i>External Joinery</i>	Aluminum, Material in, Good Condition.
<i>Window sills</i>	Brick veneer, Good Condition.
<i>Flashings over windows and door areas:</i>	Partial flashings fitted only as required.
<i>Downpipes:</i>	PVC, Secured, Material in, Good Condition.
<i>Exterior Taps:</i>	Tested, working.
<i>Storm water:</i>	P.V.C, Tested, draining well, Drains into street system.
<i>Ground Floor Patio:</i>	Exposed aggregate, Good Condition.
<i>Subsidence:</i>	No signs.
<i>Foundation:</i>	Concrete Floor, Good condition.
<i>Summary and comments from the inspector on this area.</i>	Good sound condition. Well constructed, in sound well presented condition.
<i>Building Exterior Image 1:</i>	Front entrance. Well fitted flashing.

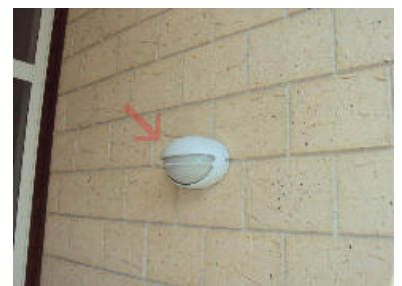
*Building Exterior Image 2:* Outside lights installed.

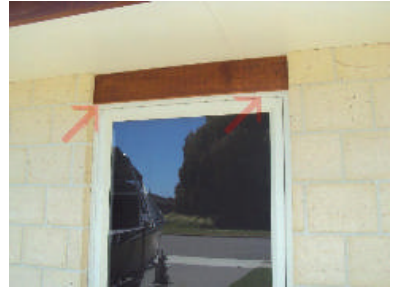
*Building Exterior Image 3:*

No Flashings fitted on any other windows. This was common practice a few years ago but is not now.

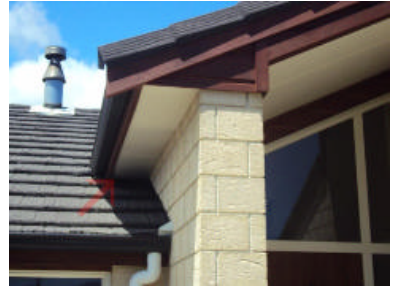
*Building Exterior Image 4:*

Birds are living in this soffit area. A simple solution to this problem would be to install a lead flashing so they can no longer get into this area.

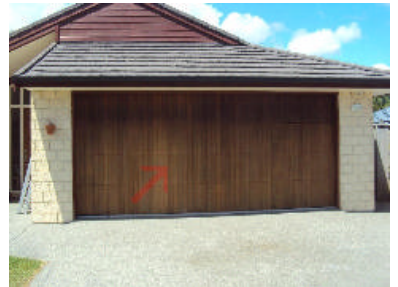
*Building Exterior Image 5:*

Tidy cedar garage door.

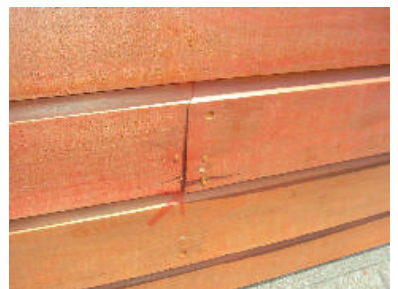
*Building Exterior Image 6:*

Cracked weatherboard.

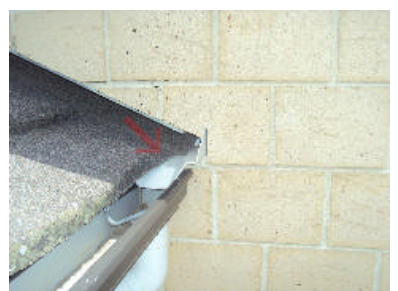
*Building Exterior Image 7:*

Good flashing system.

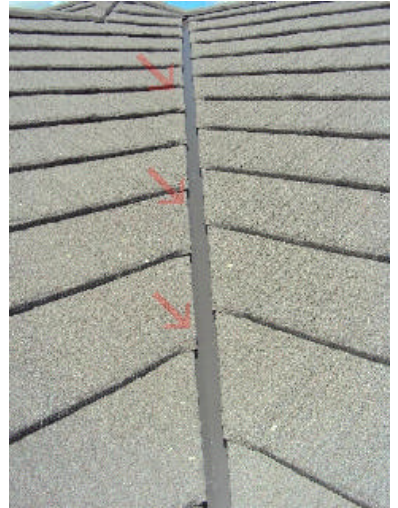
*Building Exterior Image 8:*

Valley in good condition.

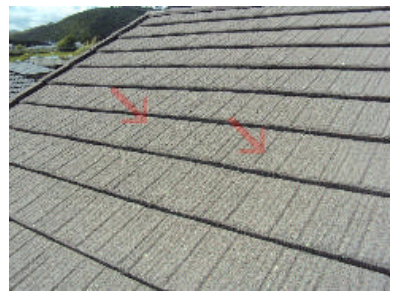
*Building Exterior Image 9:*

Roof in good condition.

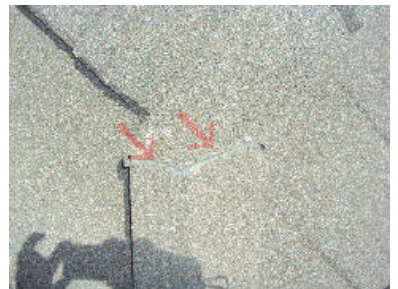
*Building Exterior Image 10:*

Keep siliconed areas well sealed, as over time they will dry up and crack in the weather.

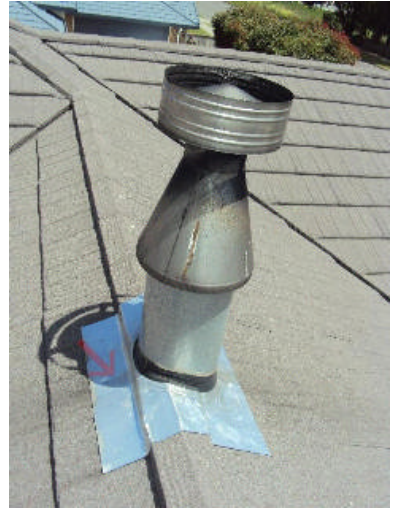
*Building Exterior Image 12:*

Well fitted flashing.

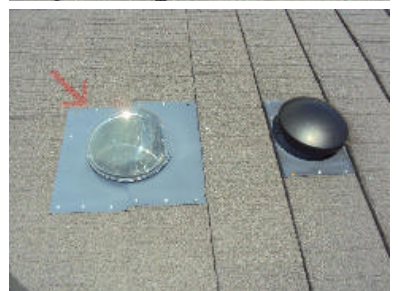
*Building Exterior Image 13:*

Skylight installed.

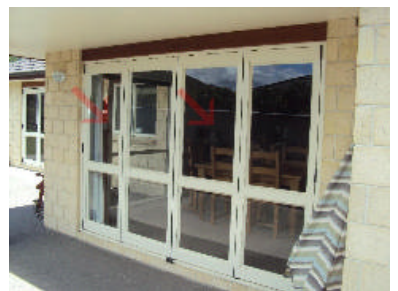
*Building Exterior Image 14:*

Bifolding doors installed, in working order.

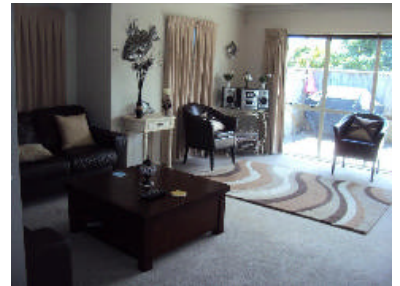
<i>General Summary, and comments from the inspector on this area:</i>	Good tidy area, well presented, functions well.
<i>Image 1:</i>	Tidy living room.

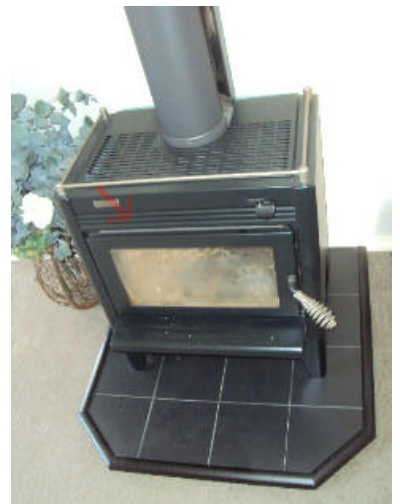
Image 3:

Fire place installed.

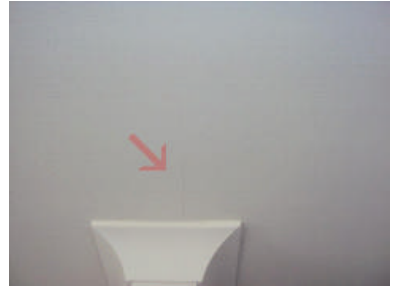
Image 4:

Crack in the plastered ceiling, not of a structural concern.

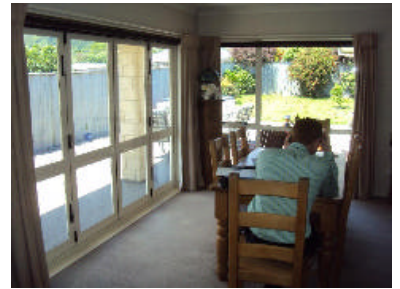
<i>General Summary, and comments from the inspector on this area:</i>	Good tidy area, well presented, functions well.
<i>Image 1:</i>	Open plan dining room and kitchen.

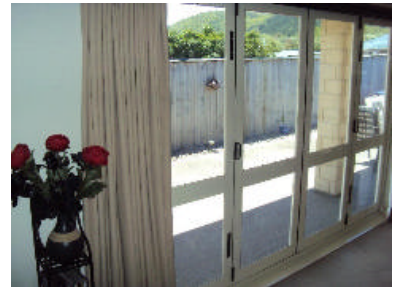
*Image 2:* Bifold doors.

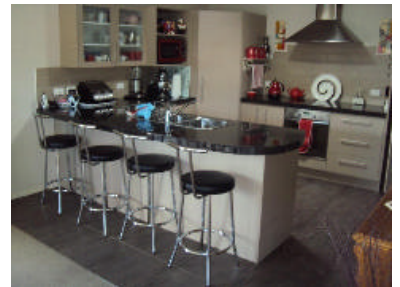
<i>Pantry doors, handles &amp; catches:</i>	Good condition, functions well.
<i>Refrigerator Area:</i>	<a href="#">Open area.</a>
<i>Sink Area:</i>	Double, Stainless steel, Draining without leaks or blockages, Good condition.
<i>Tap Area:</i>	Single mixer, Good pressure.
<i>Oven:</i>	Modern conventional type, Under bench model, Tested, working, Good condition.
<i>Oven cook top:</i>	4 Electric hot plates, Heat shield fitted, Tested, working, Good condition.
<i>Additional appliances:</i>	<a href="#">Dishwasher installed</a> , Good condition, <a href="#">Wastemaster installed</a> , Tested, working, Good condition, <a href="#">Range hood installed</a> , Tested, working, <a href="#">Tested, not working.</a>
<i>General Summary, and comments from the inspector on this area:</i>	Good tidy area, well presented.
<i>Image 1:</i>	Tidy kitchen.

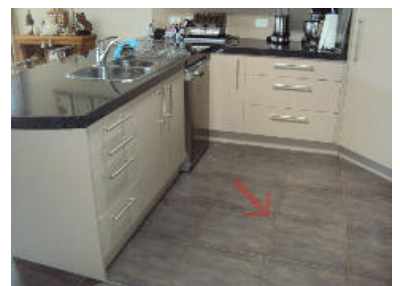
*Image 2:* Nicely tiled.

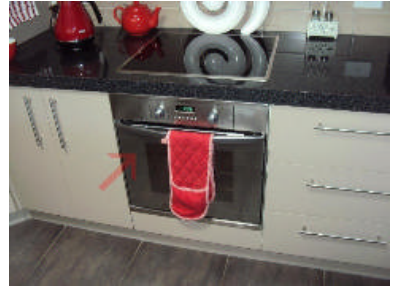
Image 3:

Oven in working order.

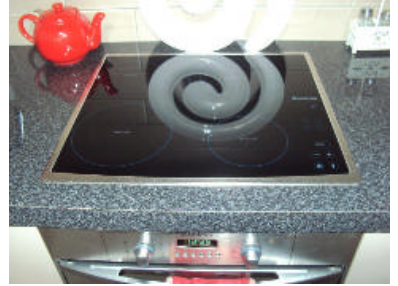
Image 4:

Soft touch stove top, in working order.

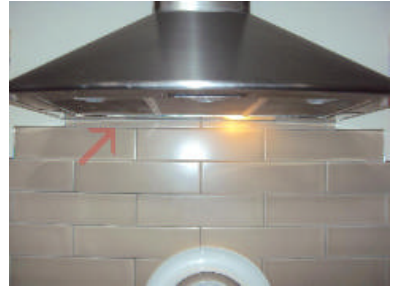
Image 5:

One light not working.

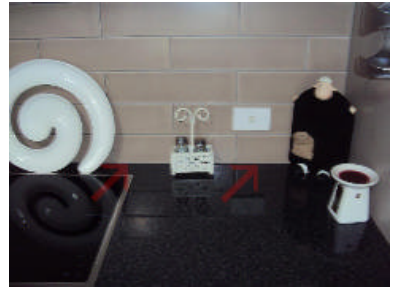
Image 6:

Well sealed junction.

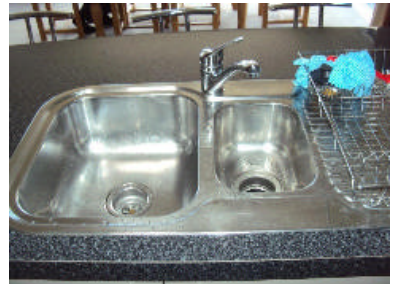
Image 7:

Sink is draining well, no leaks or blockages were found.

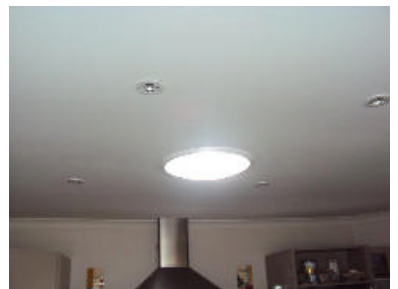
Image 8:

Sky light installed.

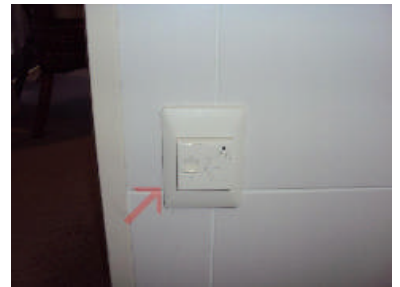
<i>Shower Base:</i>	PVC, Easy Waste Fitted, Good Condition.
<i>Shower Door:</i>	Glass door, Good Condition.
<i>Toilet Cistern:</i>	Double flush porcelain cistern, Good Condition.
<i>Toilet Seat:</i>	Plastic seat, Good Condition.
<i>Toilet Pan:</i>	Fixed firmly to floor.
<i>Towel Rail:</i>	Heated towel rail, Well secured & in good condition.
<i>Vanity Unit General:</i>	1 unit, Good Condition.
<i>Vanity Unit Top:</i>	Porcelain, Good Condition.
<i>Vanity Unit Other:</i>	Doors, Good Condition, Draws, Reasonable Condition.
<i>Vanity Unit Taps:</i>	Single water mixer, Good water pressure.
<i>Extraction and Heating:</i>	No Heating, Extraction fan, Tested, Good working condition.
<i>General Summary, and comments from the inspector on this area:</i>	Good tidy area, well presented. Well sealed area. Good functioning area.
<i>Image 1:</i>	Underfloor heating panel.

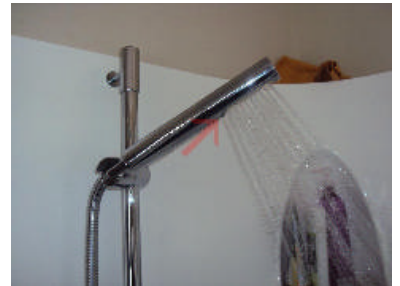
<i>General:</i>	Separate room.
<i>Internal ceiling and wall linings:</i>	Base linings intact, Good Condition.
<i>Window sash and function:</i>	Single glazed, Aluminum frame, Awning, Functions as designed, Good Condition.
<i>Window Reveals &amp; Sills</i>	Base materials are in, Good Condition, Painted.
<i>Door types and function standards for this room:</i>	Hinged door, Function as designed, Good Condition.
<i>Door panels and door reveals:</i>	Base materials are in, Good Condition.
<i>Door Hardware:</i>	No real requirement for door stop here.
<i>Lighting:</i>	Installed.
<i>Tested:</i>	Tested, working.
<i>Power Points &amp; Sockets:</i>	Single Switch Socket.
<i>Tested:</i>	Tested, working.
<i>Floor Covering:</i>	Tile fitted, Good Condition.
<i>Shower:</i>	PVC linings, Good Condition.
<i>Shower Water Control:</i>	Hand held shower rose, Single mixer, Reasonable, Remedial attention suggested, Leaking water control evident.

*Image 2:* Slight leak from the shower rose.

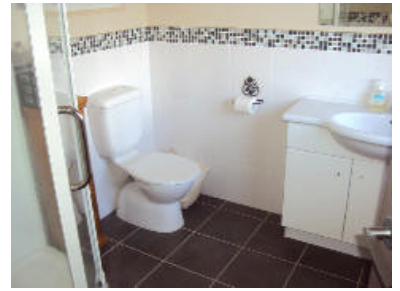
Image 3:

Well presented bathroom.

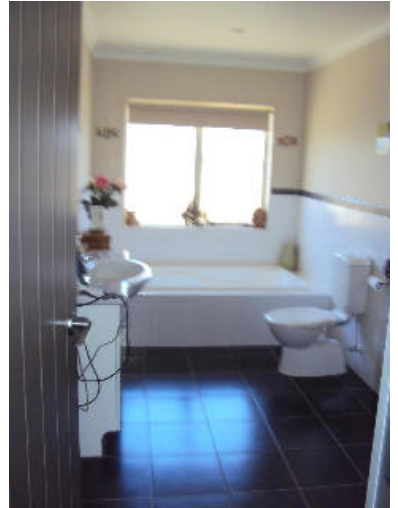
Image 1:

Main bathroom, well presented room.

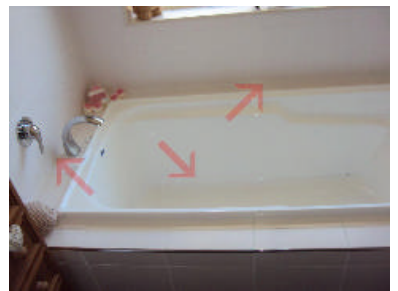
Image 2:

Well sealed tiles around the bath, good bath surface.

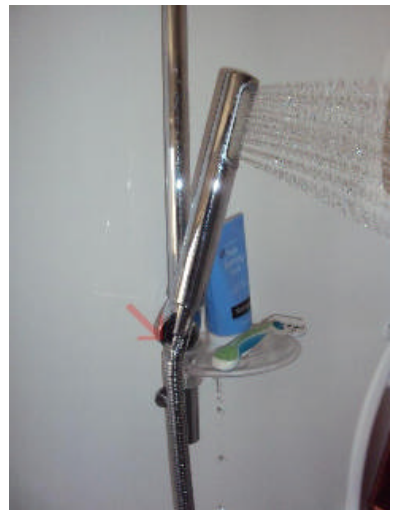
Image 3:

<i>Shower Water Control:</i>	Hand held shower rose, Single mixer, Reasonable, <b>Remedial attention suggested, Leaking water control evident.</b>
<i>Shower Base:</i>	PVC, Easy Waste Fitted, Good Condition.
<i>Shower Door:</i>	Glass door, Good Condition.
<i>Toilet Cistern:</i>	Double flush porcelain cistern, Good Condition.
<i>Toilet Seat:</i>	Plastic seat, Good Condition.
<i>Toilet Pan:</i>	Fixed firmly to floor.
<i>Towel Rail:</i>	Heated towel rail, Well secured & in good condition.
<i>Vanity Unit General:</i>	1 unit, Good Condition.
<i>Vanity Unit Top:</i>	Porcelain, Good Condition.
<i>Vanity Unit Other:</i>	Doors, Good Condition, Draws, Good Condition.
<i>Vanity Unit Taps:</i>	Single water mixer, Good water pressure.
<i>Extraction and Heating:</i>	No Heating, Extraction fan, Tested, Good working condition.
<i>General Summary, and comments from the inspector on this area:</i>	Good tidy area, well presented. Well sealed area. Good functioning area.

Shower rose is leaking.

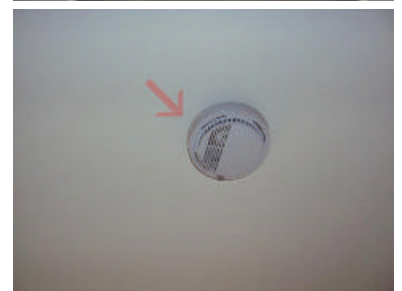
*Image 2:* Smoke alarms installed, tested and working.

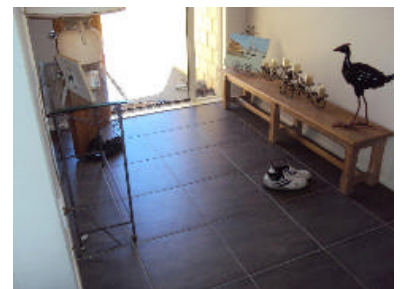
*Image 3:* Tiles front entrance.

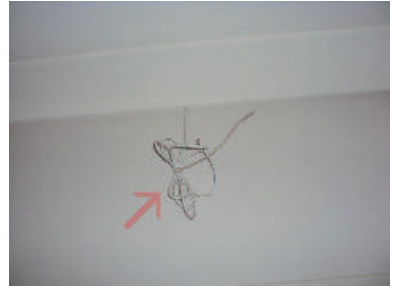
Image 4:

Wires hanging out of the ceiling.

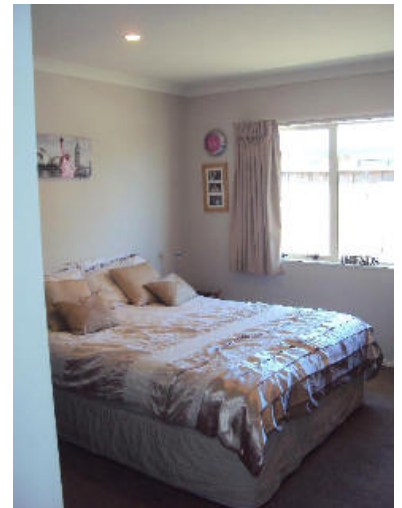
<i>General Summary, and comments from the inspector on this area:</i>	Good tidy area, well presented, functions well.
<i>Image 1:</i>	Tidy bedroom.

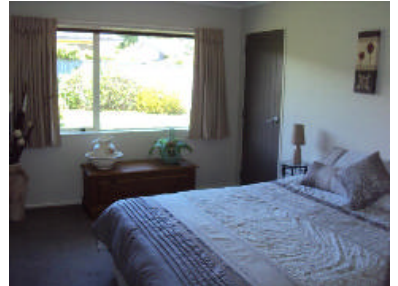
*Smoke Alarms:* No Smoke Alarms.  
*Wardrobe:* Single size.  
*Wardrobe Doors:* Hinged design, Functions as designed, Good Condition.  
*General Summary, and comments from the inspector on this area:* Good tidy area, well presented, functions well.  
*Image 1:* Tidy second bedroom.

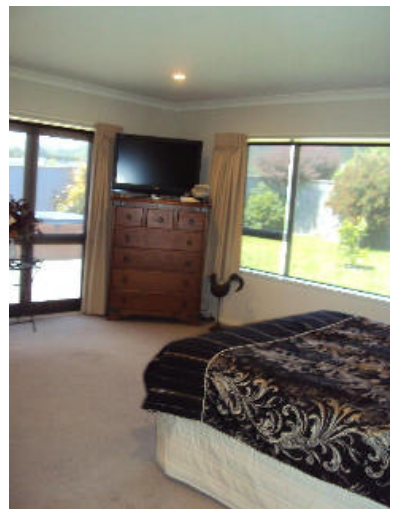
*General Summary, and comments from the inspector on this area:* Good tidy area, well presented, functions well.  
*Image 1:* Tidy master bedroom.

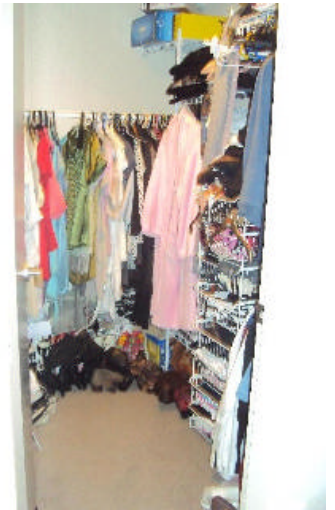
Image 2:

Walk in wardrobe.

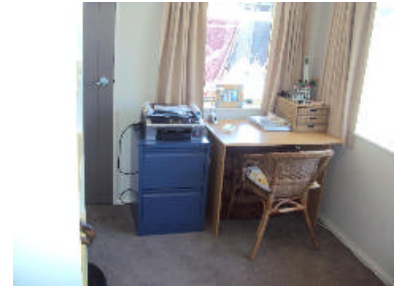
<i>General Summary, and comments from the inspector on this area:</i>	Good tidy area, well presented, functions well.
<i>Image 1:</i>	Tidy study.

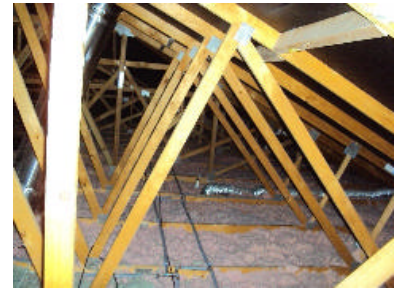
<i>Ceiling construct</i>	Ceiling baton construction in this dwelling, The ceiling baton construction here is tidy, and in a good sound condition.
<i>Pest &amp; debris, timber rot:</i>	No pest or debris evident in the internal ceiling space.
<i>Summary for this area</i>	Good, tidy, sound condition. No remedial tasks required, no issues of any kind in this area.
<i>Image 1:</i>	Good solid, secured trusses.

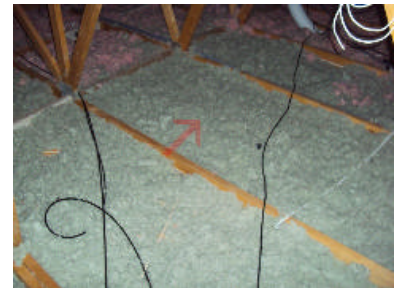
*Image 2:* Insulation installed.

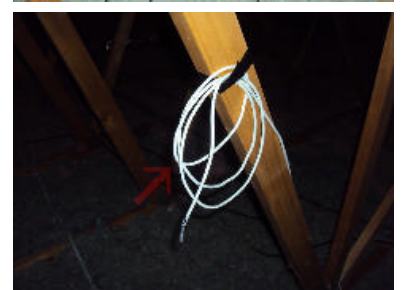
*Image 3:* Loose wires in different areas of the ceiling space, these are for hard wired smoke alarms that have not been installed.

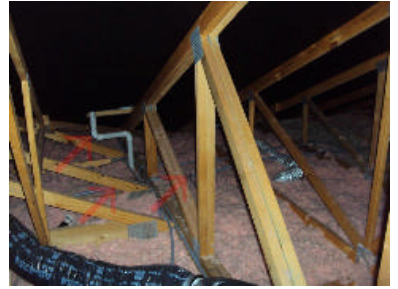
Image 4:

Good tidy plumbing.

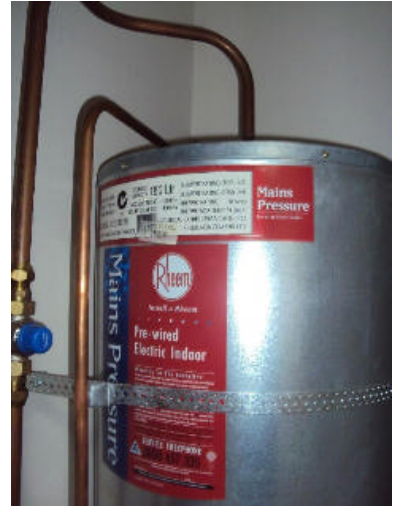
*Image 1:*

*General comments on the cylinder and connections:* The cylinder carcass and the connections here are in a good sound condition. No sign of any damage or moisture leaks evident on the day of inspection.
