# Property Inspection Report

- The Habit Wellington Ltd -

## Inspection Details - Property Inspection Report

*Date:* 23/11/2010.  
*Time of Appointment:* 01:00 p.m.  
*Inspection For:* Paul 027 5555 725

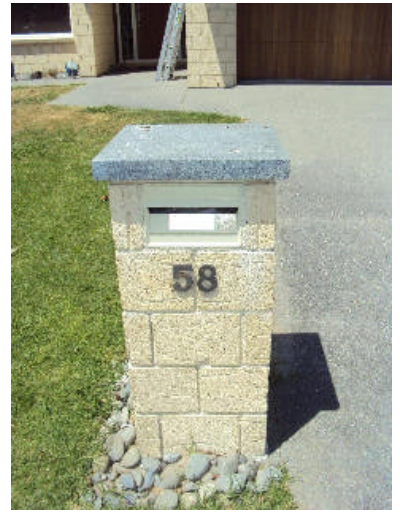
<i>Section details:</i>	Level site.
<i>Main water supply, on/off control:</i>	Road side area.
<i>Driveway:</i>	Exposed aggregate, Good fall for drainage, Good condition.
<i>Fencing General:</i>	Timber Fencing material in: Reasonable Condition.
<i>Gates Installed</i>	Timber Reasonable condition.
<i>Patio Area:</i>	Exposed aggregate, Good Condition.
<i>Clothesline:</i>	Fold away, Good Condition.
<i>Paths:</i>	Concrete, Exposed aggregate, Good Condition.
<i>Water Pooling:</i>	Water pooling not likely on this site.
<i>Summary and comments from the inspector on this area:</i>	This site is in a well established and well presented condition.
<i>Image Site Area 1:</i>

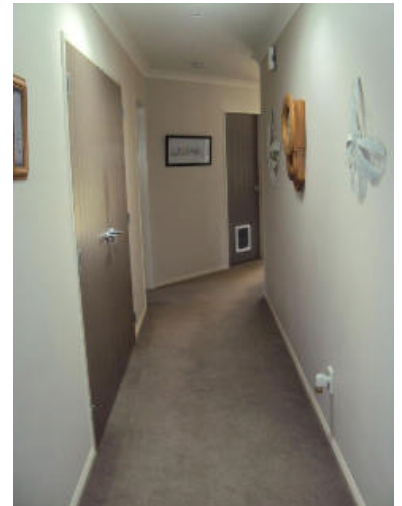
<i>Image 1:</i>

<i>Internal ceiling and wall linings:</i>	Base linings intact, Good Condition.
<i>Window sash and function:</i>	No windows installed in this area.
<i>Door types and function standards for this room:</i>	Hinged door, Function as designed, Good Condition.
<i>Door panels and door reveals:</i>	Base materials are in, Good Condition.
<i>Lighting:</i>	Installed.
<i>Tested:</i>	Tested, working.
<i>Power Points &amp; Sockets:</i>	Multiple, Single Switch Socket.
<i>Tested:</i>	Tested, working.
<i>Floor Covering:</i>	Carpet fitted, Tile fitted, Good Condition.
<i>Heating:</i>	Ducted heat system, Professionally Installed, Operational, Good condition.
<i>Smoke Alarms:</i>	Multiple, Securely Installed, Tested, working.
<i>Storage:</i>	Storage cupboards here.
<i>Storage area doors:</i>	Hinged door, Function as designed, Good Condition.
<i>General Summary, and comments from the inspector on this area:</i>	Good tidy area, well presented, functions well.
